**Flood Control Project Maintenance
Levee Inspections**

Fall 2015 Levee Maintenance Deficiency Summary Report

Sacramento River Basin

Reclamation District No. 0501 Ryer Island

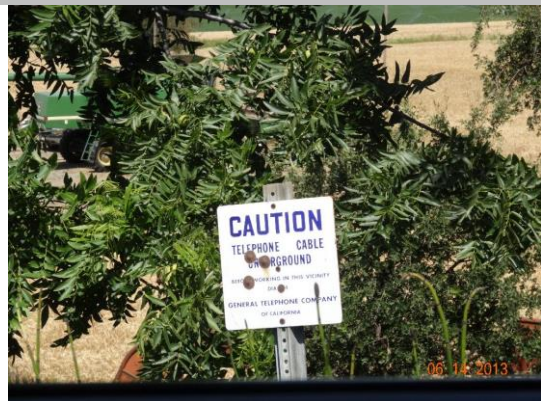
Photo 2 of 3 : UCIP_FA_2015_3556.jpg

Marker visible on landward side.

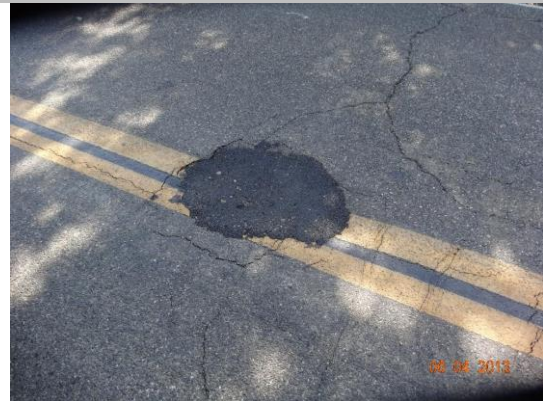
Photo 1 of 3 : UCIP_FA_2015_3655.jpg

Subsidence and patch work repair on crown.

UCIP Comments: Damage present on levee crown--unable to confirm if damage due to leak in pipe. Signs of repair work on crown, however, no permit found to document recent damage to levee or repair work. New PVC pipe has been sleeved through the existing 6-inch pipe. Unable to determine if crossing is still in use, if not, crossings needs to be removed according to CVFPB Title 23 requirements.

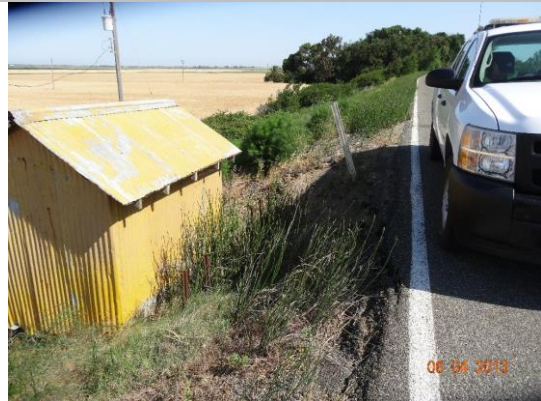
Photo 2 of 3 : UCIP_FA_2015_3691.jpg

Overview of landside. Pump house and power pole visible on landward side.

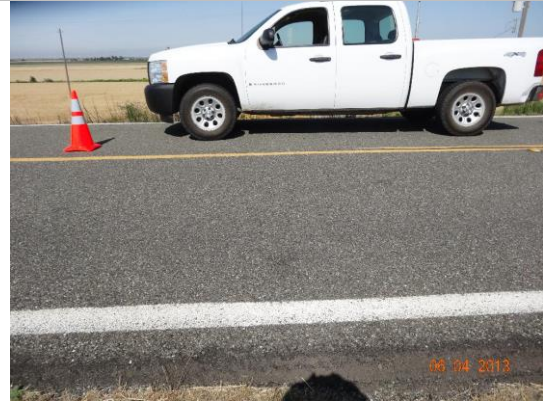
Photo 3 of 3 : UCIP_FA_2015_3692.jpg

Crown hinge point damaged, roadway section missing.

View of crown

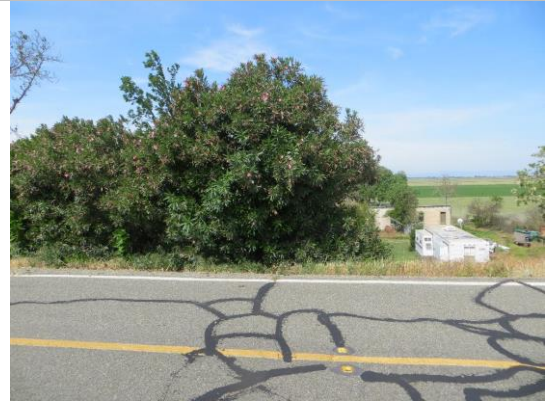
Photo 1 of 3 : UCIP_FA_2015_6840.jpg

Pipes visible under oleander on LS shoulder.

Action/Comments					
Inspector Comments: FS_ID:44643 DS_ID:21089 EP_NO: 2683 FS_HLM: 0.69 Repair Type: Non-Urgent Crossing Status: Indicator Found UCIP Comments: Appears abandoned and if so should be done so properly. FIELD_STRUCT_DESC: 2-inch steel water pipe and 1-inch steel electrical conduit through the levee, both 3.0 feet below the crown. Portion of pipe visible under oleanders on LS shoulder may be part of this crossing. No evidence remains on WS slope. FS Date: 04/21/2015

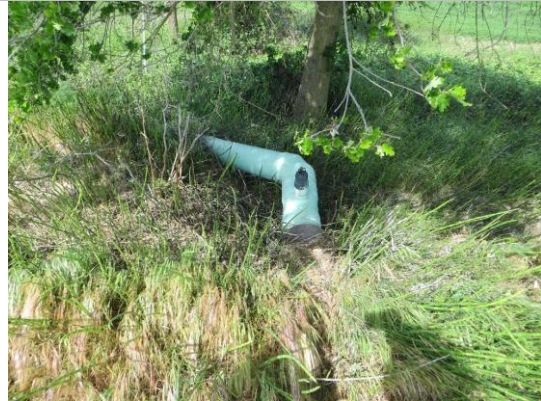
Photo 1 of 3 : UCIP_FA_2015_6843.jpg

Pipes and siphon breaker on LS shoulder.

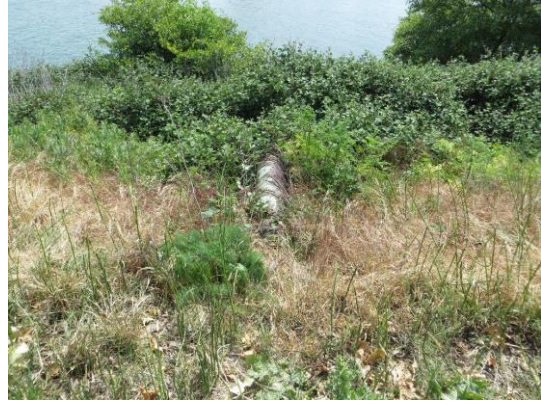
Photo 2 of 3 : UCIP_FA_2015_6844.jpg

Pipes visible on WS slope.

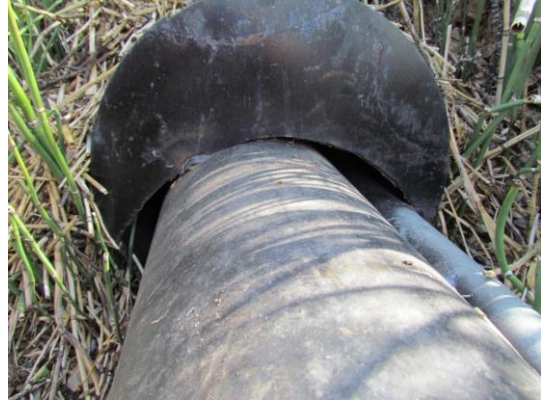
Photo 1 of 2 : FA_2015_RD0501_169_73_20150915_00006.jpg

LM Start	1.84	Rating **	U	Issue No.	73
LM End	1.84	Issue Type +	En	Location *	LS
Category	Earthen Levee			GPS Latitude/Longitude	
				Start	End
Item	Encroachments			38.228399 °	38.228399 °
				-121.604134 °	-121.604134 °
DWR ID	DWR_RD0501_01_s_2014_73				
Action/Comments					
Pipe					
Inspector Comments: Pipe has been replaced but the job is not complete. 4-02-2014. This project as of 11-6-2014 has not been completed. The grouting has not been done.

Looking at the unfinished pipe work at levee mile 1.84.

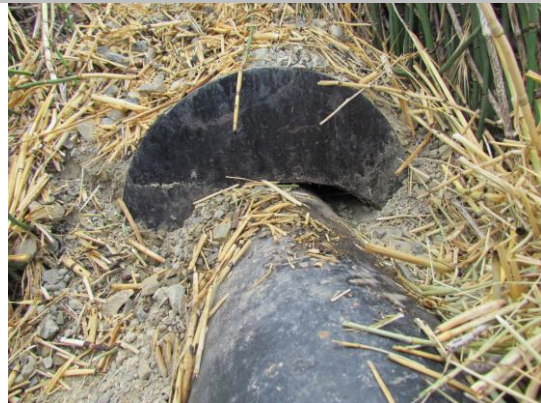
Photo 2 of 2 : FA_2015_RD0501_169_73_20151005_00013.jpg

Looking at this unfinished pipe work on the landward levee slope partially covered with dirt.

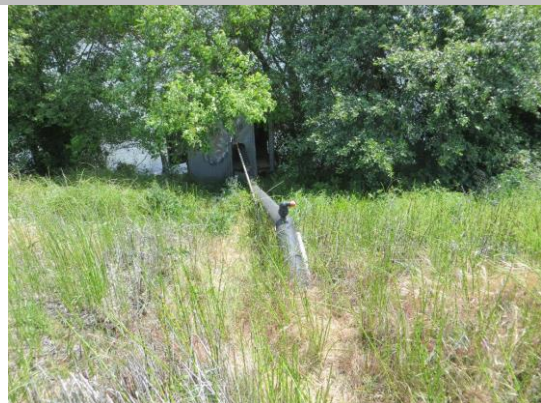
Photo 1 of 3 : UCIP_FA_2015_6150.jpg

8-inch steel pipe with vent/siphon breaker on WS shoulder. Pipe sleeved through 14-inch steel pipe. Electrical conduit visible next to pipe.

Inspector Comments: FS_ID:44659
 DS_ID:21086
 EP_NO: 13233
 FS_HLM: 1.84
 Repair Type: Non-Urgent
 Crossing Status: Found
 UCIP Comments: Annular space between pipes not grouted. Steel plate partially covers openings between pipes.
 FIELD_STRUCT_DESC: 14-inch steel pipe through the levee, 2.5-feet below the crown. Cutoff wall around pipe at center of levee. Pump and check valve in pump house on waterward slope. Service pole on landward slope. (Permit No. 13233-1982) 8-inch steel irrigation pipe sleeved through 14-inch (under Permit No. 11813-1, 2013). A 1.5 and a 2.5-inch electrical conduit at same location. Siphon breaker on both shoulders.
 FS Date: 04/21/2015

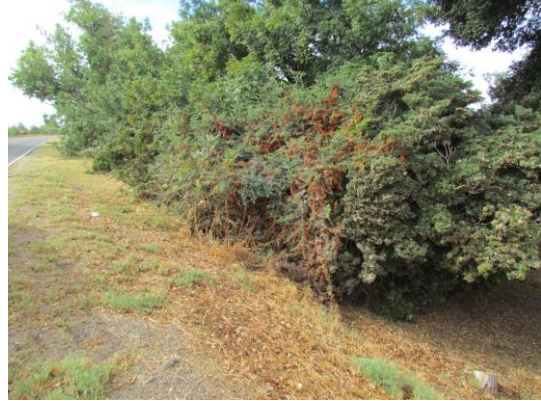
Photo 1 of 1 : FA_2015_RD0501_169_116_20151005_00014.jpg

Looking downstream at the woody tree growth on the landward levee slope.

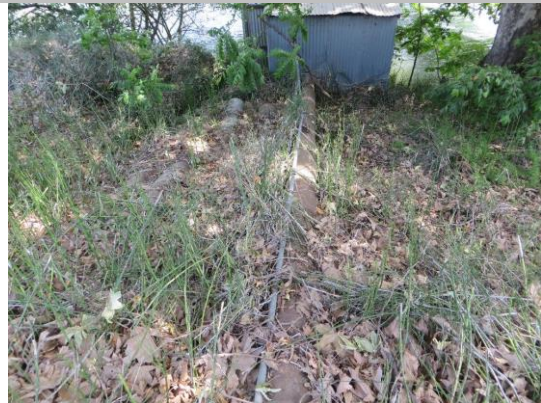
Photo 2 of 3 : UCIP_FA_2015_6154.jpg

Inspector Comments: FS_ID:44683
 DS_ID:21021
 EP_NO: N/A
 FS_HLM: 2.343
 Repair Type: Non-Urgent
 Crossing Status: Found
 UCIP Comments: Appears abandoned and if so should be done so properly. Discarded pipe on WS slope should be removed.
 FIELD_STRUCT_DESC: 10-inch steel irrigation pipe through the levee, 2.5-feet below the crown. Pump and gate valve in pump house on waterward slope. a 4'X4' concrete distribution box, power pole, and meter on LS toe (USACE-1959). This entry matches the Drainage or Irrigation Structure referenced in O&M manual (HLM 2.50).
 FS Date: 04/21/2015

Pipe and pumphouse on WS slope.

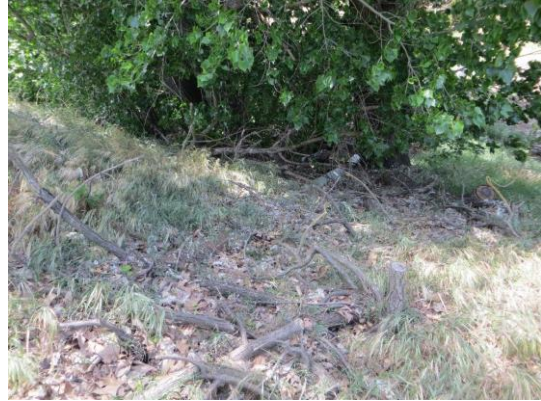
Photo 3 of 3 : UCIP_FA_2015_6155.jpg

Pipe visible on LS slope.

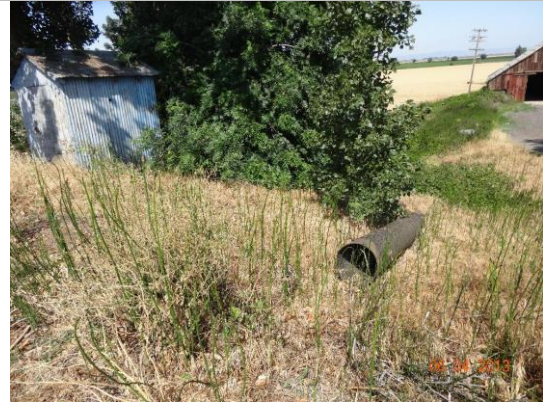
Photo 3 of 3 : UCIP_FA_2015_3698.jpg

Pump house on landward slope. An abandoned pipe section on landward slope.

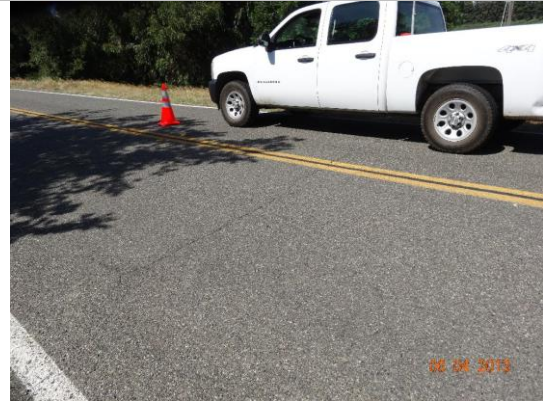
Photo 2 of 3 : UCIP_FA_2015_3700.jpg

View of levee crown at crossing. Single line crack on levee crown.

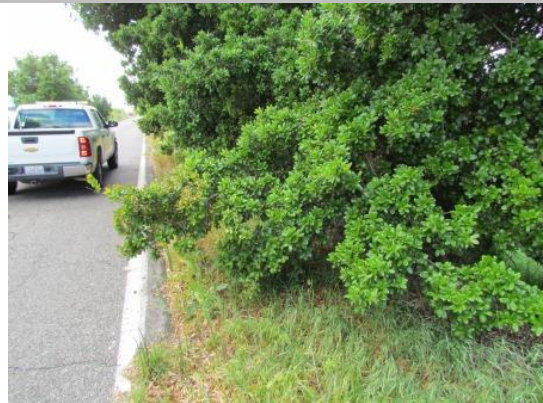
Photo 1 of 1 : FA_2015_RD0501_169_43_20150915_00004.jpg

Woody tree growth on levee slope and shoulder of the landside. No new photo taken.

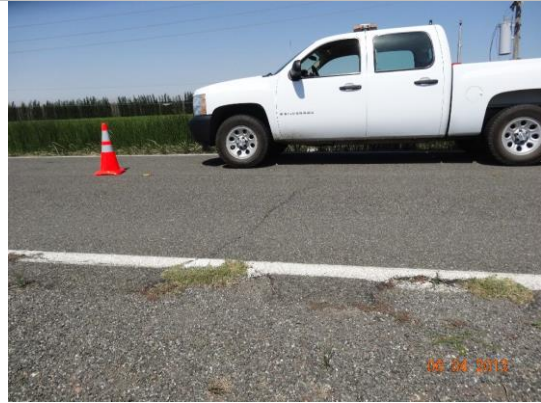
Photo 3 of 3 : UCIP_FA_2015_3704.jpg

Single line crack on crown.

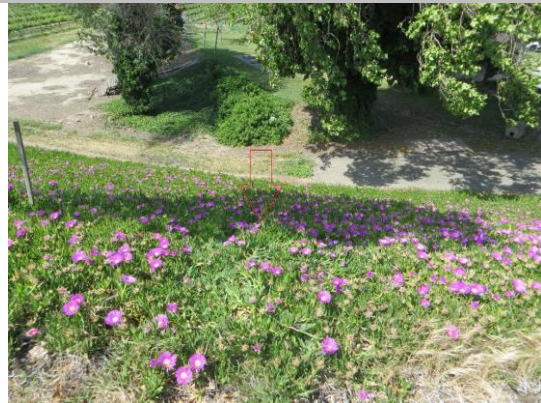
Photo 2 of 3 : UCIP_FA_2015_6226.jpg

Mound at pipe visible on LS slope.

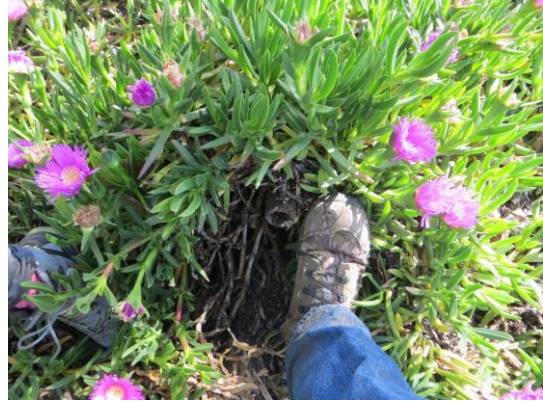
Photo 3 of 3 : UCIP_FA_2015_6227.jpg

Pipe visible on LS slope. Succulants mound up over pipe.

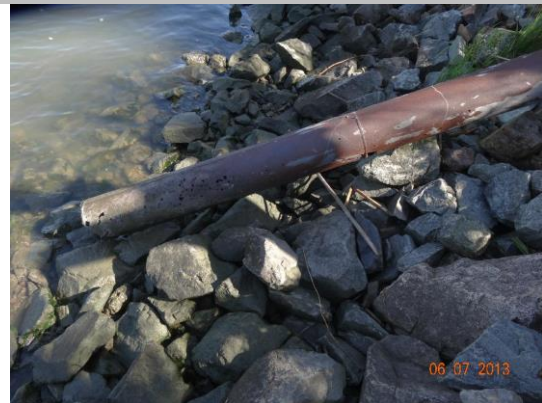
Photo 2 of 3 : UCIP_FA_2015_3889.jpg

Deteriorated pipe with visible holes through pipe wall.

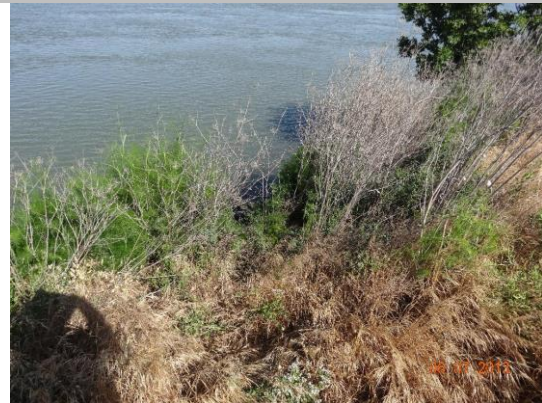
Photo 2 of 3 : UCIP_FA_2015_3892.jpg

View of waterward side--dense vegetation limits inspection. Unable to locate pipe on waterward side.

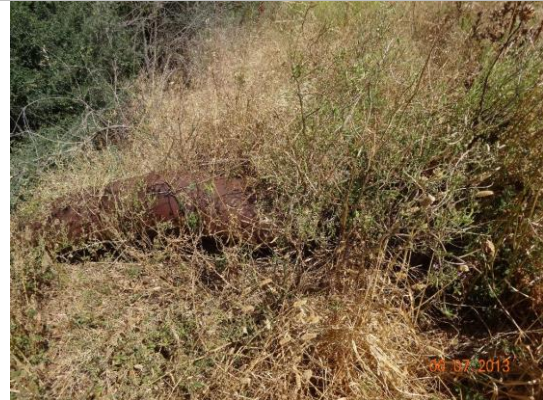
Photo 3 of 3 : UCIP_FA_2015_1860.jpg

Dense vegetation along the upper portion of the waterward slope prevents proper inspection of crossing.

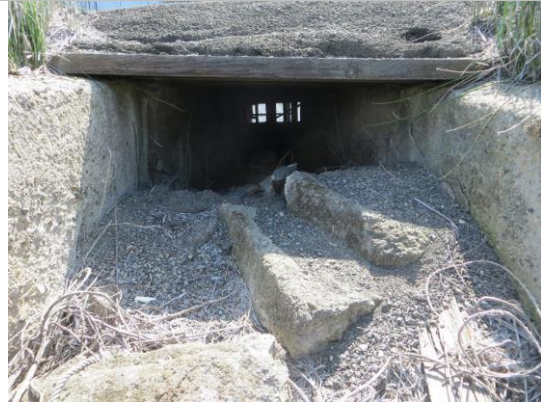
Photo 1 of 3 : UCIP_FA_2015_5510.jpg

Tunnel open on both ends.

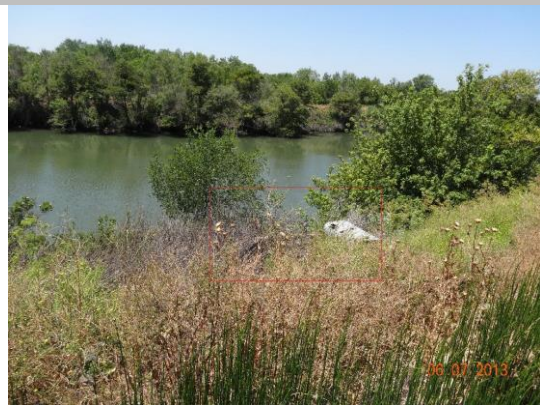
Photo 3 of 3 : UCIP_FA_2015_1969.jpg

View of waterward side. Dense vegetation limits inspections. Signs of structure visible highlighted by red box.

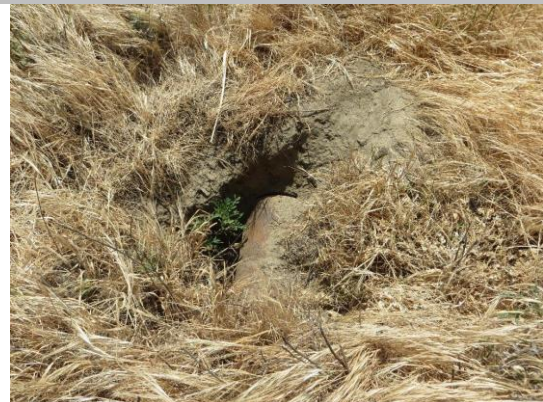
Photo 1 of 2 : UCIP_FA_2015_6256.jpg

Cut in buried pipe on LS shoulder.

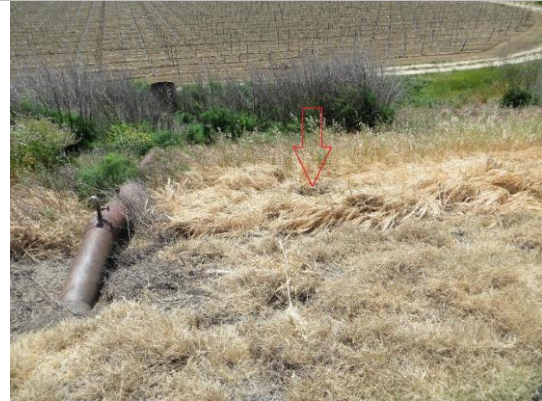
Photo 2 of 2 : UCIP_FA_2015_6257.jpg

Buried pipe exposed in trench 8-feet downstream from visible pipe.

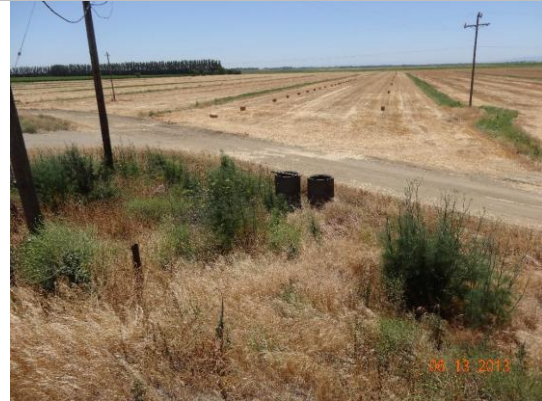
Photo 4 of 4 : UCIP_FA_2015_3135.jpg

Dry vegetation throughout the landward slope.

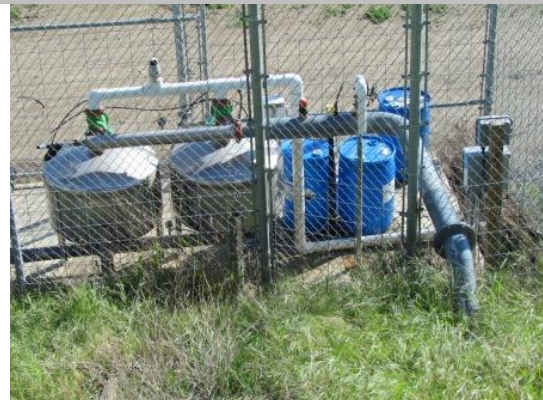
Photo 1 of 1 : FA_2015_RD0501_171_28_20150915_00002.jpg

This filtration system sits within 10-foot of the landward toe, there is no CVFPB permit on file.

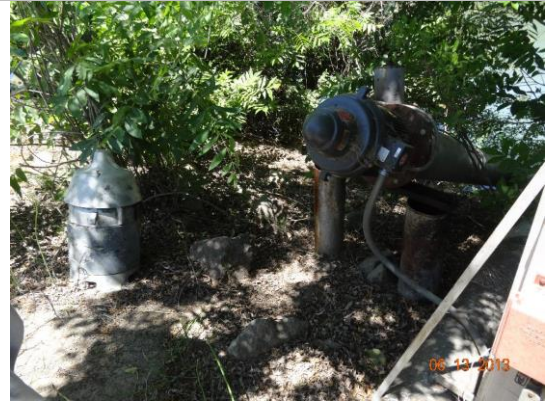
Photo 1 of 3 : UCIP_FA_2015_4030.jpg

Slant pump located on waterward side. An abandoned pump left on waterward side.
